## PROFESSIONAL INSPECTION REPORT

**INSPECTION #** 072115PB2.  
**CLIENT NAME:** The City of Yachats.  
**DATE OF INSPECTION:** 07/21/2015.  
**INSPECTION LOCATION:** 501 N. Hwy 101, Yachats, OR 97498.

**ESTIMATED AGE OF STRUCTURE(S):** The building (complex) was built in approximately 1993.  
**BUILDING TYPE:** Bank.  
**STORIES:** 1.

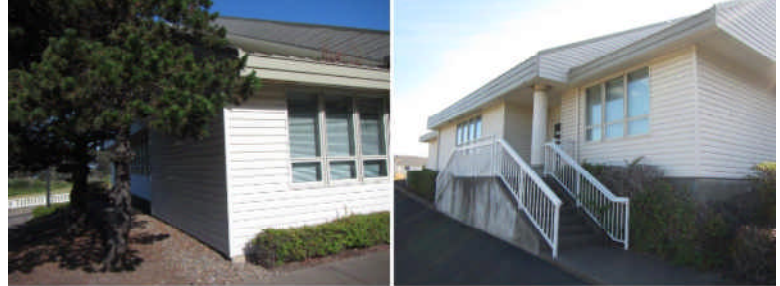
Trim plants away from structure. Vegetation is in contact with the building at various locations and tree contact at the SE corner. Trim back all vegetation.

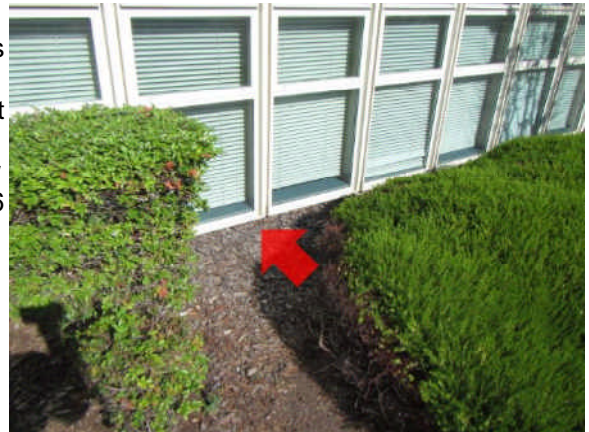
Flat site, Grade at foundation appears sufficient, The grade is in contact with or less than 6" away from the siding/framing at the following sides of the building: east, Lower soil below siding. The Grade should be 6 inches below any wood materials while providing slope away from the foundation.

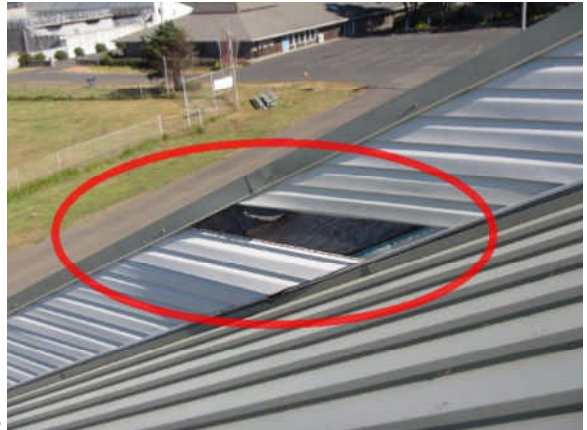
General condition of siding is good however, an area of missing/damaged siding was noted at the south side of the west upper roof area: The siding has blown off and has resulted in exposed plywood sheathing and active water penetration: Repairs are needed: Call a qualified, licensed contractor to make further evaluation and repairs as needed. The potential for hidden damage/rot/mold exists.

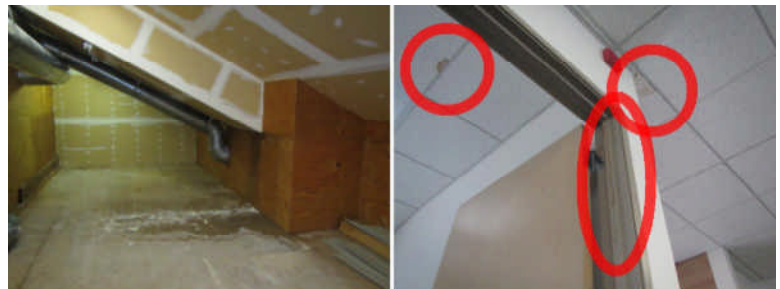
Stains at the "attic" area and ceiling panels in the office below this area were observed. Recommendation:

Photos of water stains in the attic and at the ceiling tiles below the missing siding.

Various stains were noted at the area around the SW office room: This staining appears to be consistent with leakage seen at the missing siding as noted above this area: Replace stained/damaged ceiling tiles.

[Repair/Service.](#)

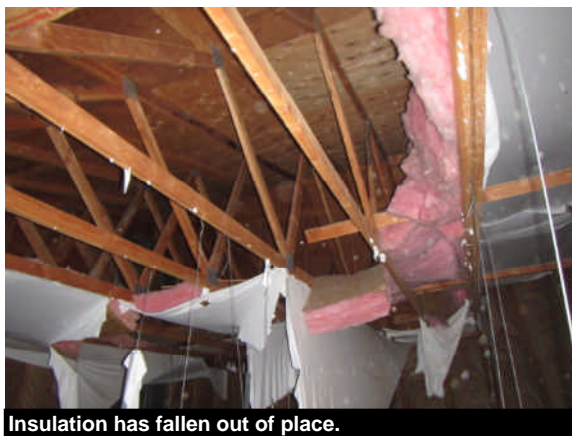
Fiberglass batts. Good condition where visible/ accessible however, the most of insulation at the south end of the building has fallen out of place: Replacement of this insulation is needed.

Insulation has fallen out of place.

Recommendation: Repair/Service.

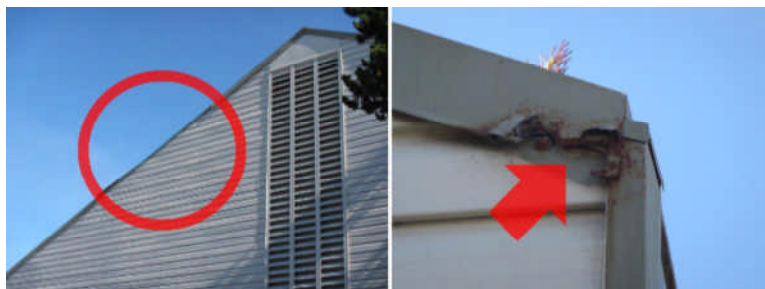
Painted metal flashings. Fair condition: Various areas of rusted/failing flashing were noted. Also the SW edge flashing is loose/fallen out of place:

Recommendation: Repair/Service.

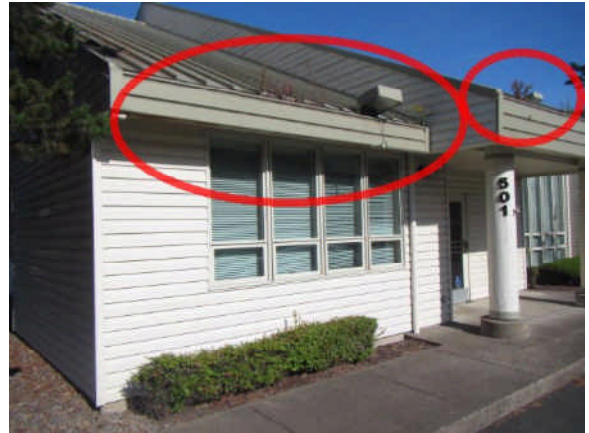
Full, integral gutters/drains.  
General condition of gutters  
and downspouts is good.  
Debris in gutter: Cleaning is  
needed now and regularly for  
proper operation.

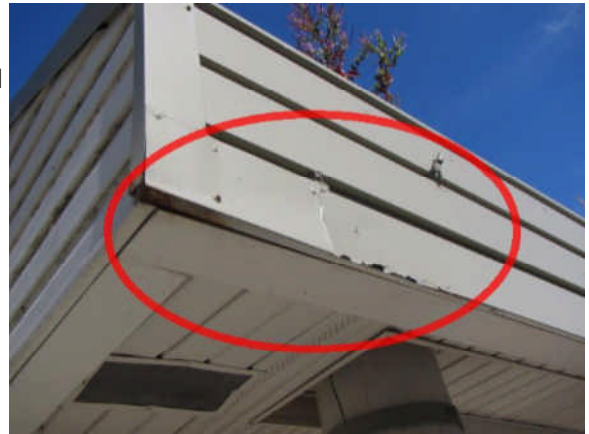
The predominant fascia  
material is metal faced. The  
condition of the underling wood  
was not determined. The  
predominant soffit material is  
vinyl. The metal fascia and trim  
is rusted at various locations:  
Rusted fascia/trim should be  
replaced: Call a qualified,  
licensed contractor.  
Recommendation: Repair/  
Service.

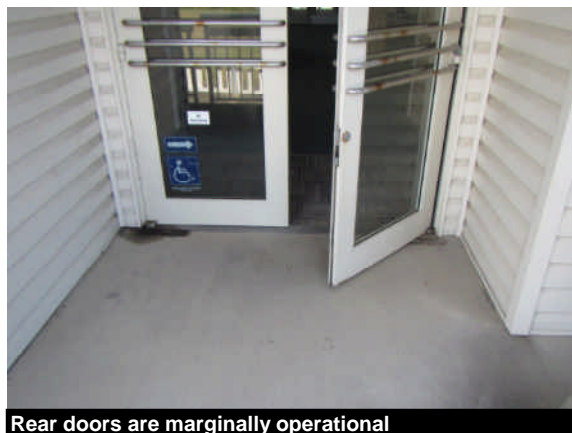
General condition of exterior doors is good to fair: The rear, west doors are in need of adjustments/repairs. The doors do not operate properly. Recommendation: [Repair/Service](#).

Rear doors are marginally operational

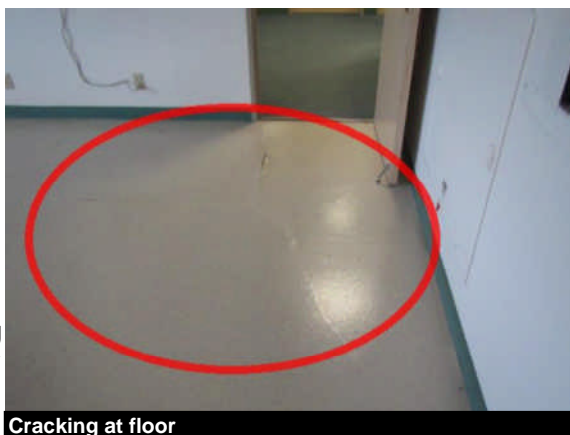
Damaged flooring and cracking at the concrete slab at the break room indicates shrinkage and possible settlement: See foundation notes below.

General condition of foundation is good. Cracking was noted at the floor in the break room:

This cracking is consistent with shrinkage and possible minor settlement: The closet door in this room rubs at the floor and will not shut as a result: Cracking/Settlement is likely old but, I can not verify active movement: Consider consulting with a professional engineer for further evaluation and consultation. Recommendation:

Cracking at floor

**Evaluate**.

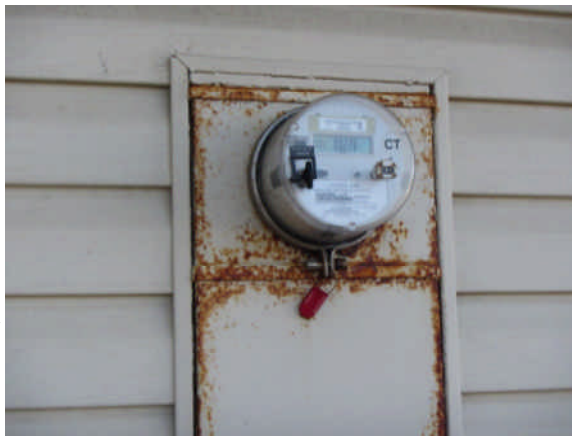
Underground, 110/220 Volt, 400 amp service. Good condition. Rust was observed at the meter base. This is common at the coastal strip however, advanced rusting and corrosion will result in hazardous conditions that will require the unit to be replaced. The rusting present at the time of the inspection did not appear to be significant to warrant replacement of the meter base. Wire brushing and re-painting are needed to prevent damage to the meter base. Recommendation: [Maintenance Needed](#).

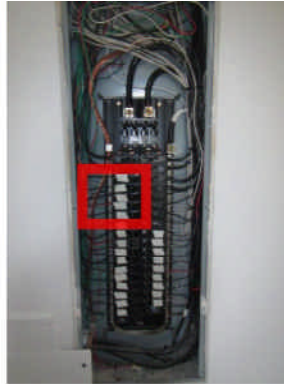
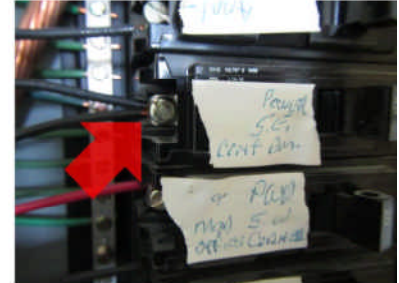
Circuit and wire sizing correct so far as visible. Circuit labeling is present: accuracy was not determined. Multiple wires are connected to a single lug on a circuit breaker at the right panel where only one wire should be connected: see photo. This is a minor issue but, should be corrected to prevent the possibility of one conductor becoming loose. Recommendation: Repair/Service.

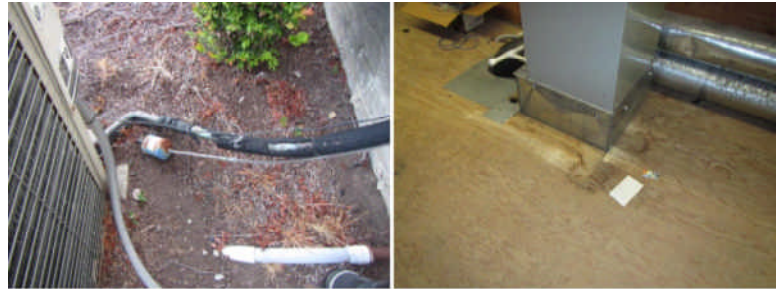
Both systems are operational and operated in both heating and cooling mode but, are in Fair/Old condition: Moderate rust was noted at the exterior components at both systems. Also signs of condensate leakage were noted at both interior air handlers/furnaces: This indicates that the condensate drains have clogged. Consider purchasing a service contract with an appropriately licensed HVAC firm in order to properly maintain your heating systems efficiency and safety. Recommendation: [Repair/Service.](#)

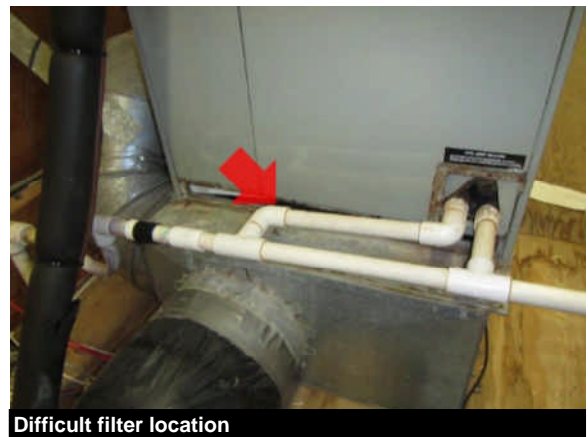
Appear adequate however, filter changing will be very difficult at the south air handler due to condensate drain location: Recommendation: [Repair/Service.](#)

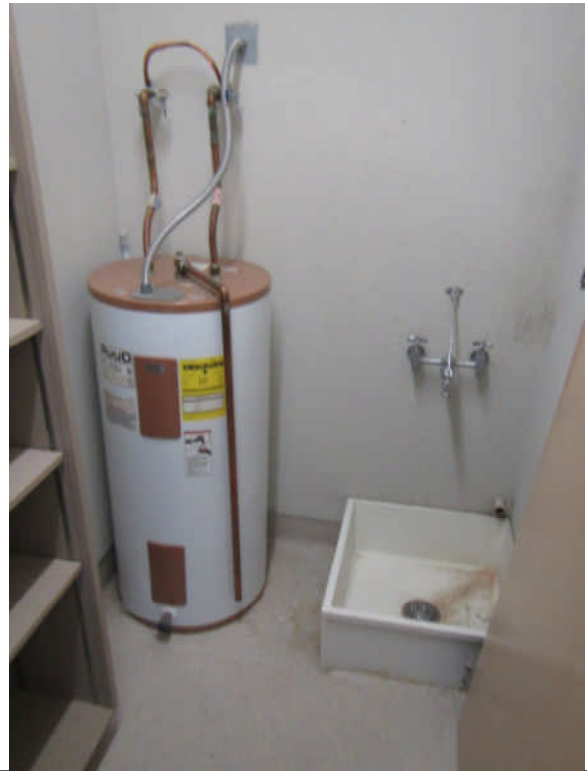
General condition of hot water heater is fair/old. The unit is original to the building: 22 years old. It is operational but, beyond the statistical life span for water heaters.

Recommendation: Monitor.

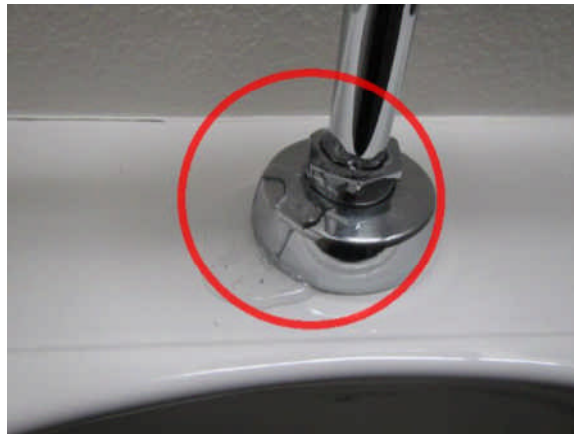
General condition of toilet is good. The urinal supply line has a leak when flushing:  
Recommendation: Repair/Service.
